# Out of the Blue

Bridgehampton, New York

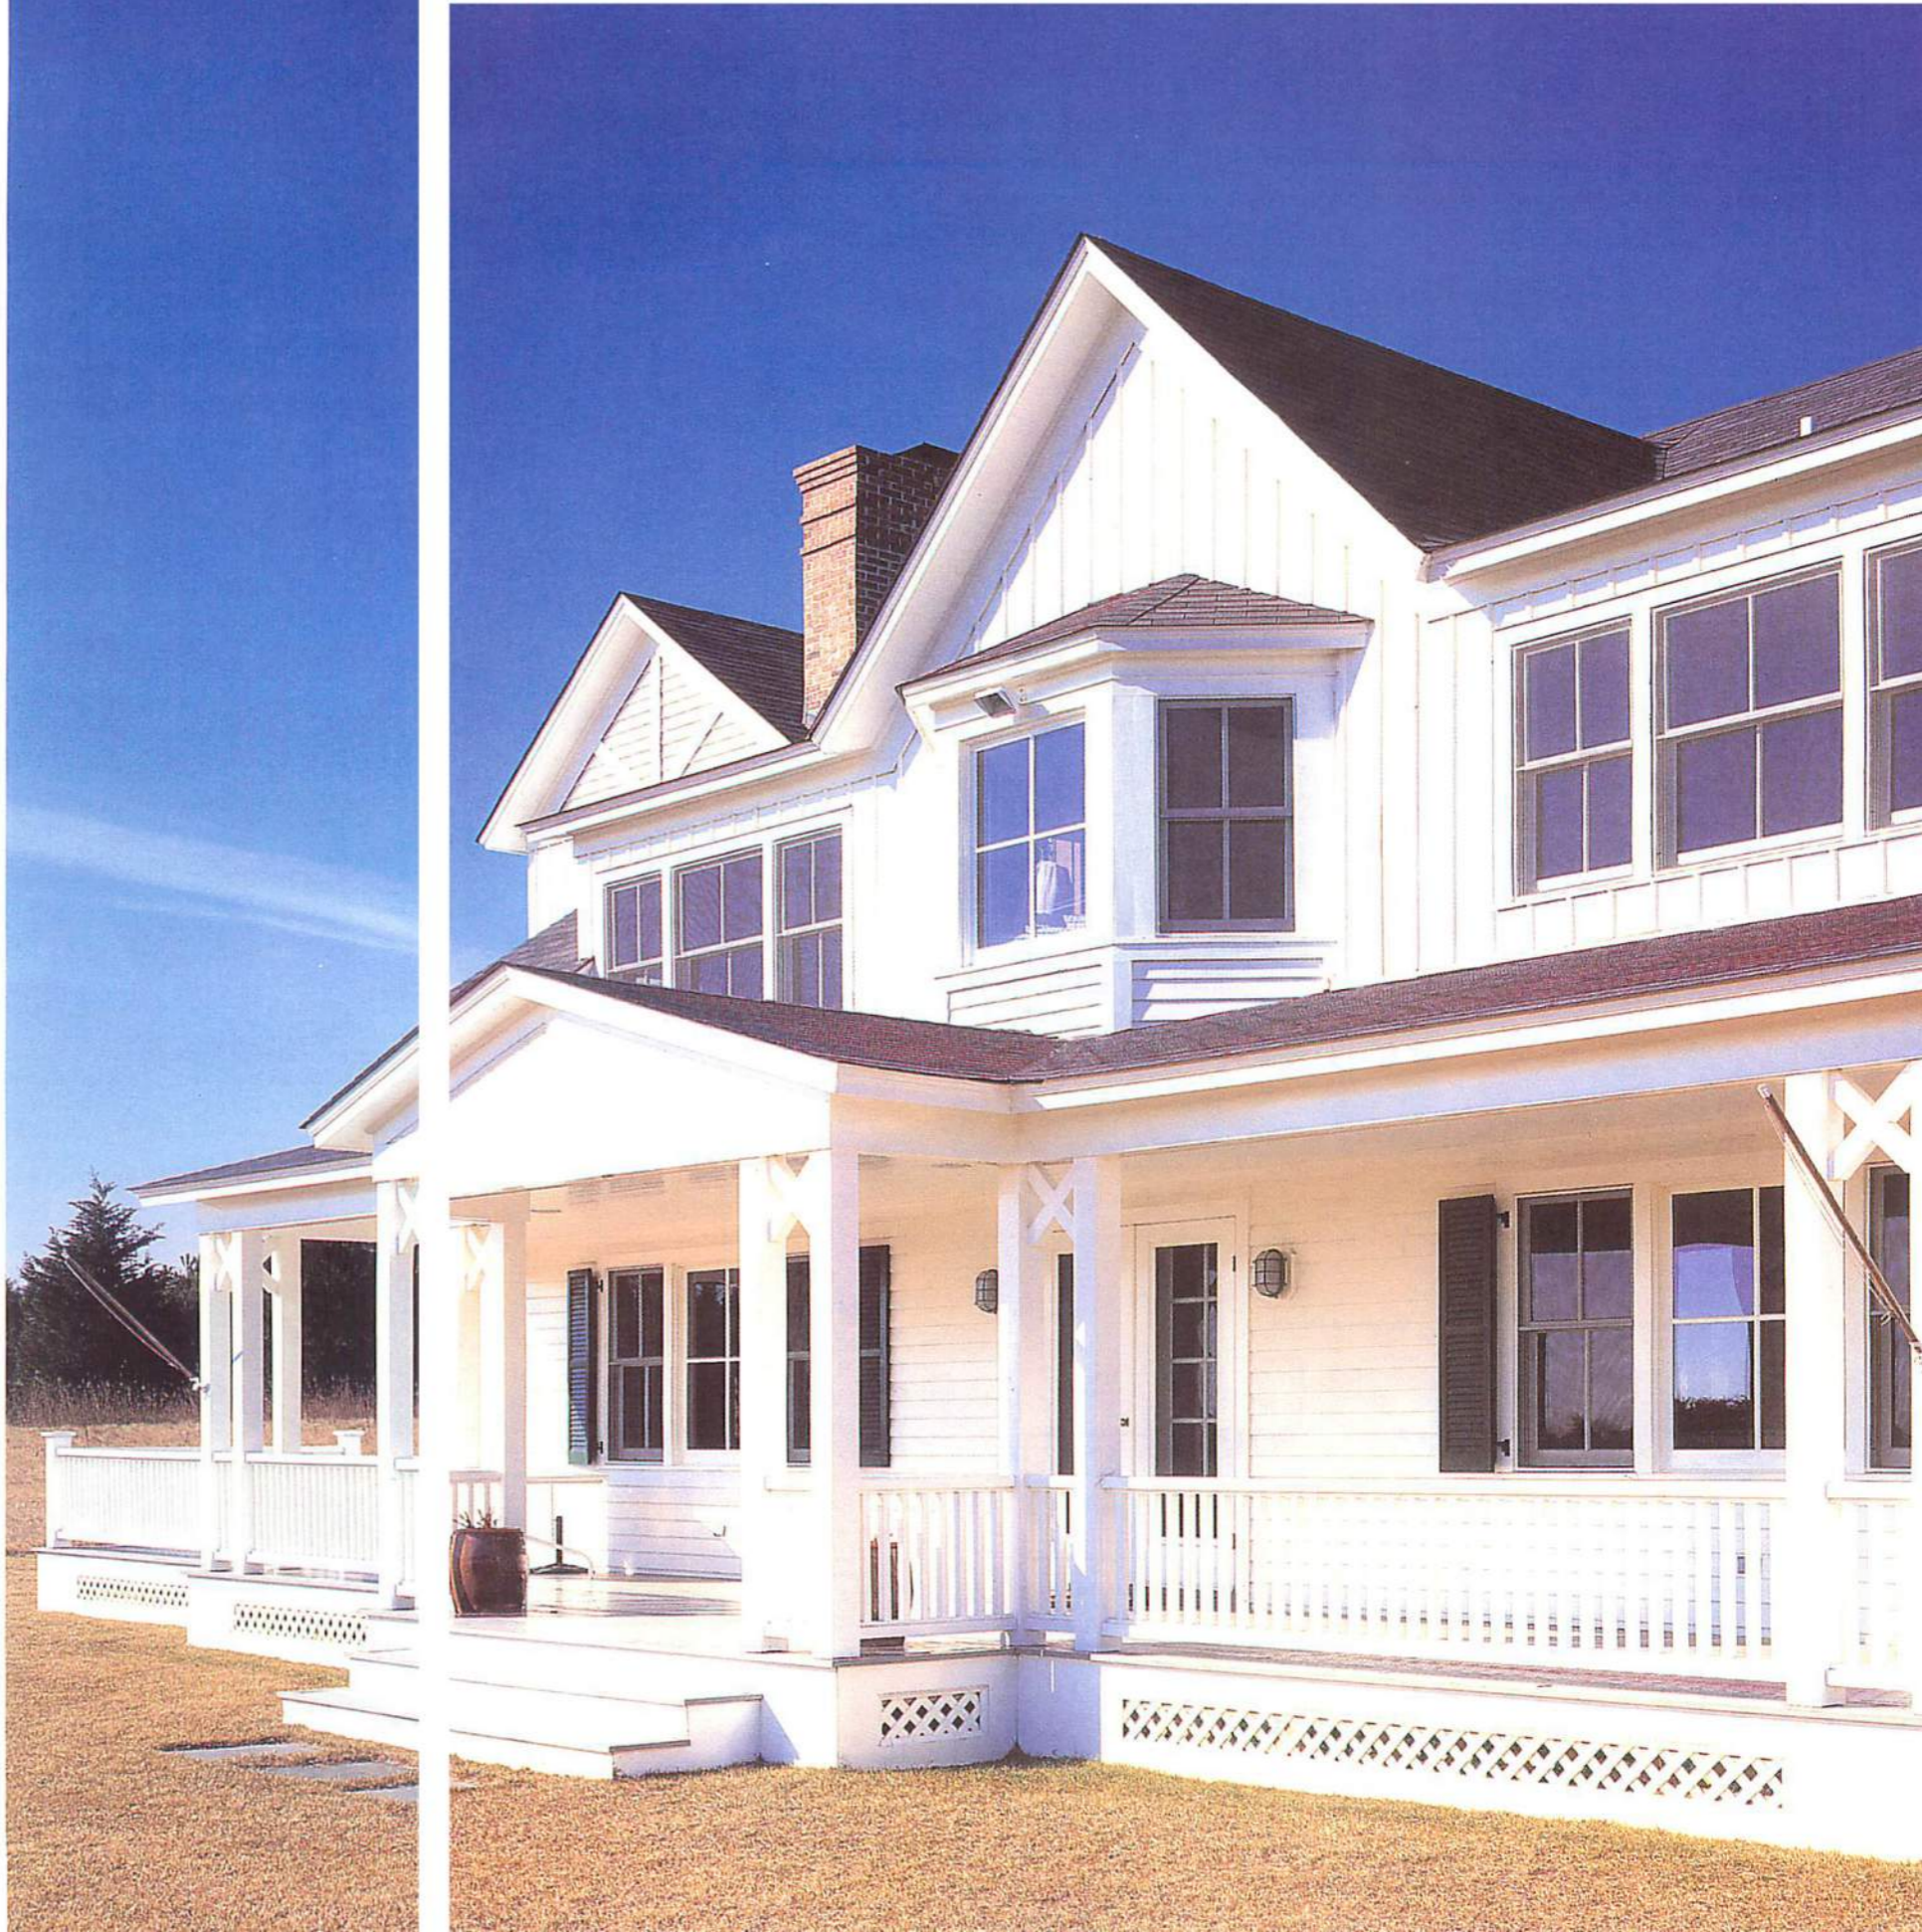
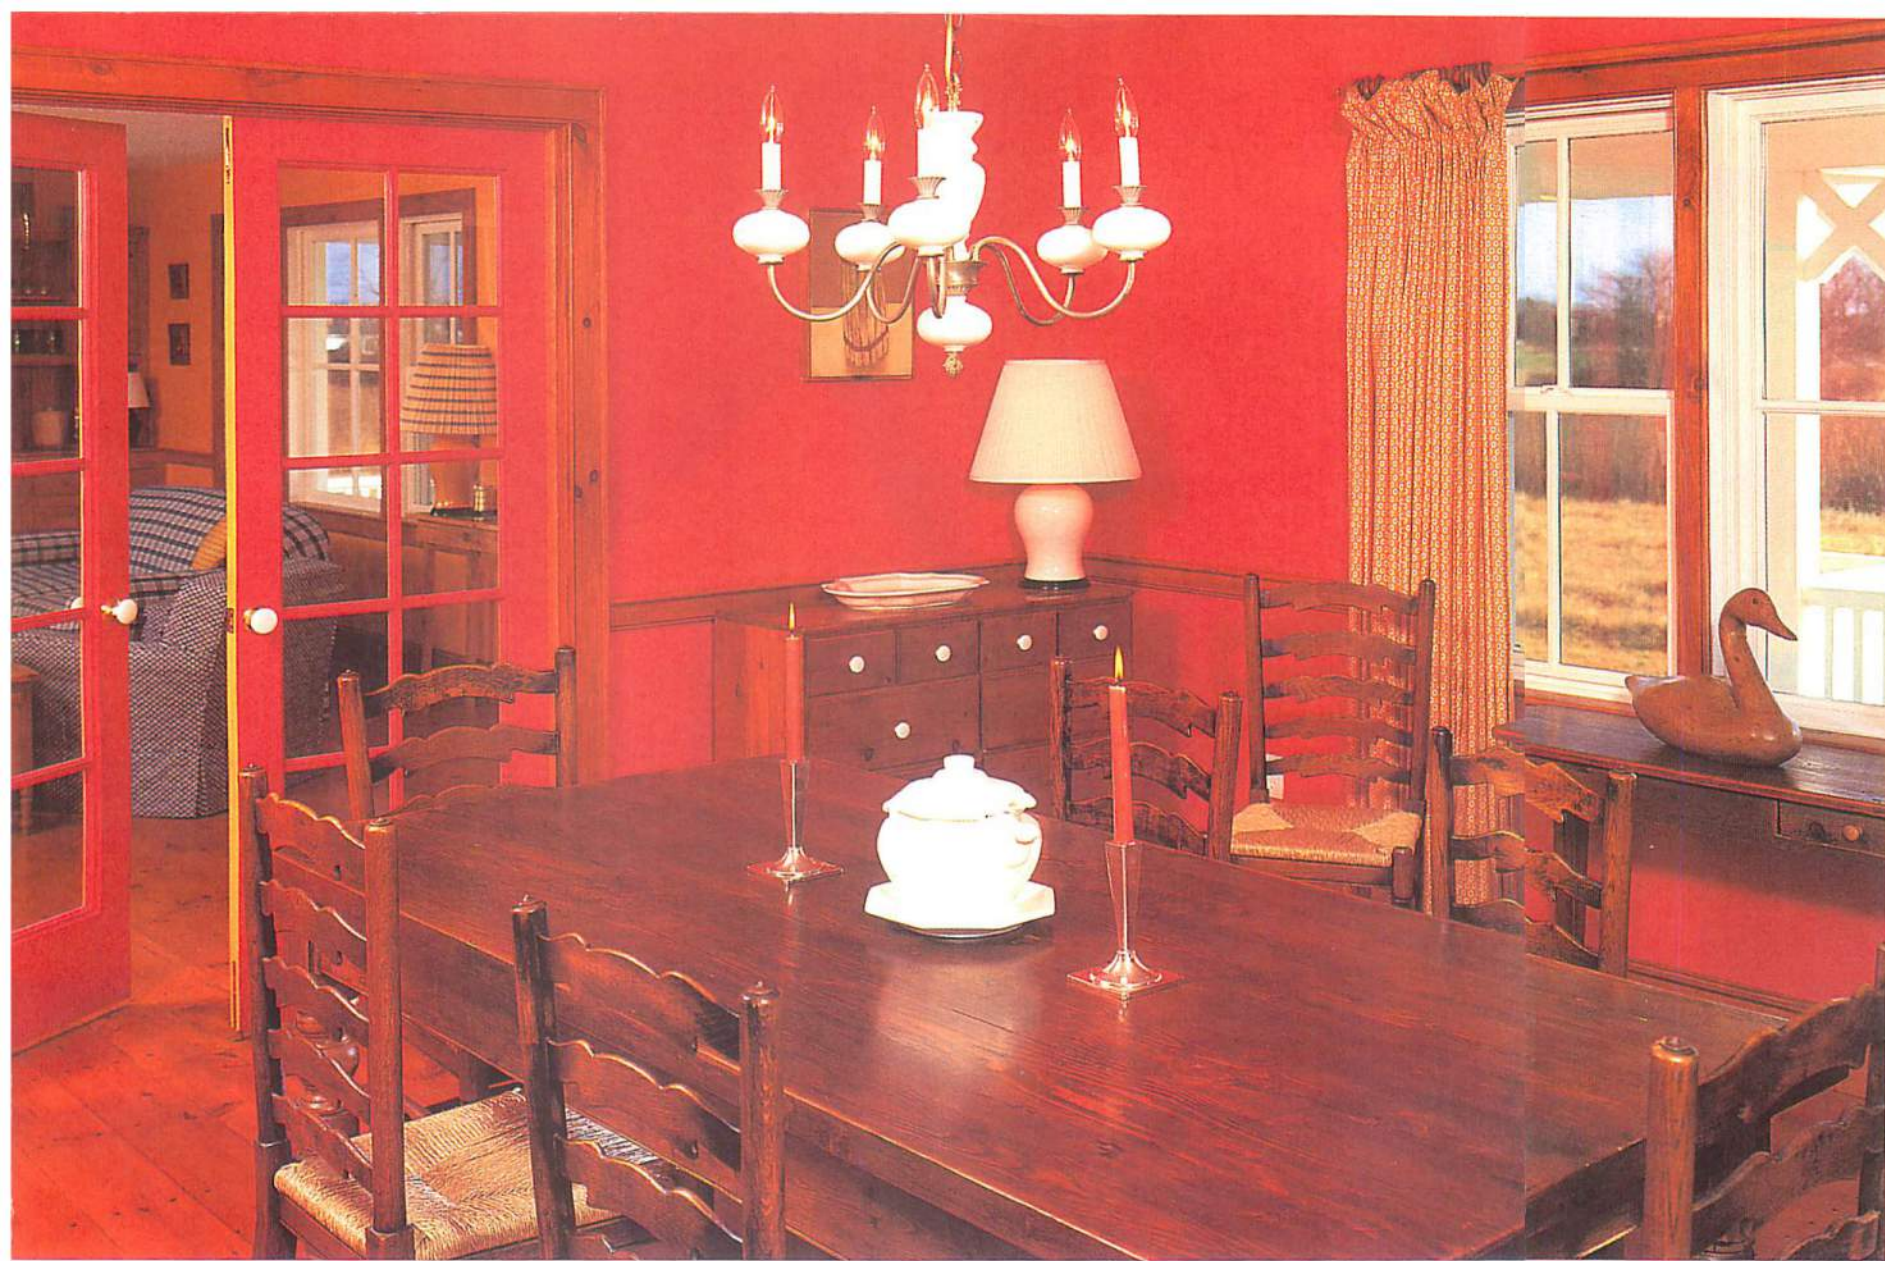
The low, east-facing mud room (above), with its small windows suggests a farm chicken coop. On the rear of the house (right), banks of double-hung windows lend detail to the traditional open porch, all finished with premium paints.

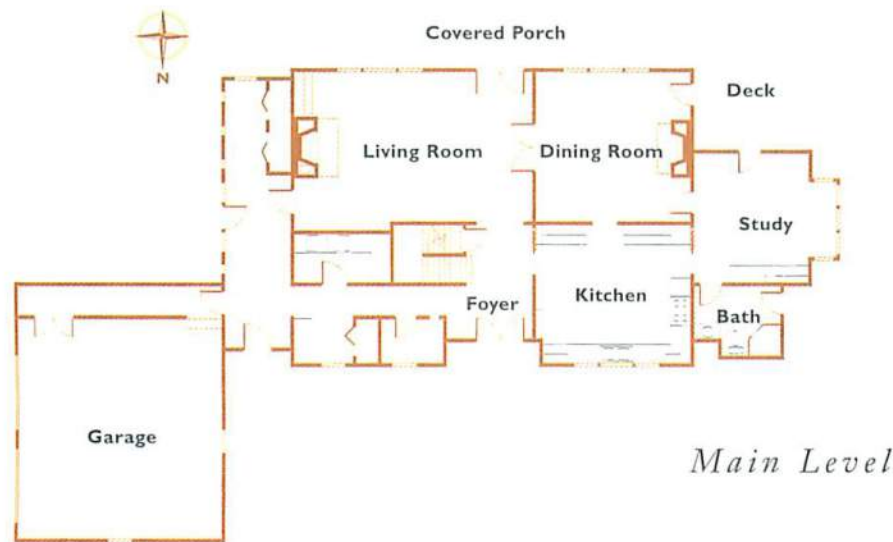
Main Level

Carefully sited for the Northeast region, the home’s front door faces north, with the two-car garage/barn situated on the northeast corner of the plan, shielding living areas from the yearly Nor’easters. At the west end of the house, a squared-off “silo” contains a lower floor study, with a sitting room on the second floor. Stacked fireplaces (for a total of four) on both ends of the house allow for wood heating in all primary living areas.

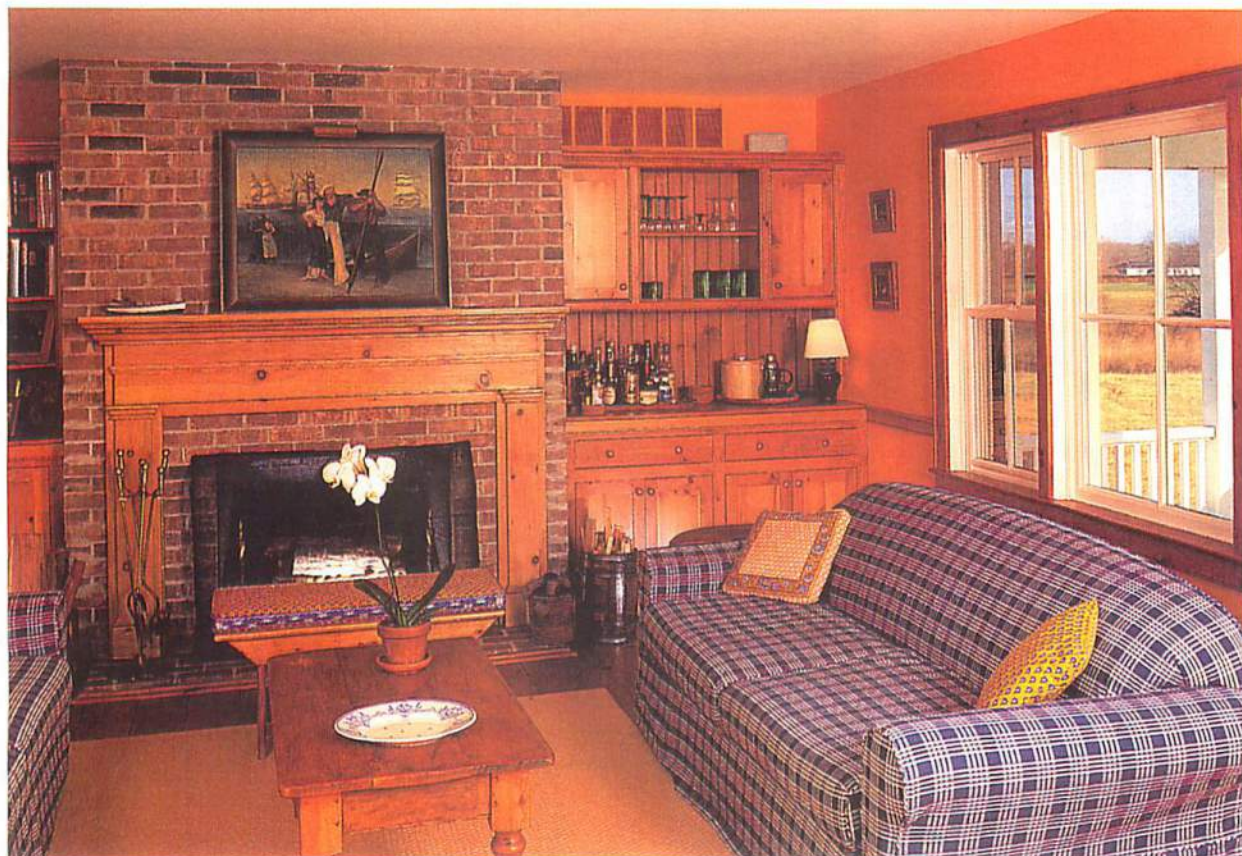
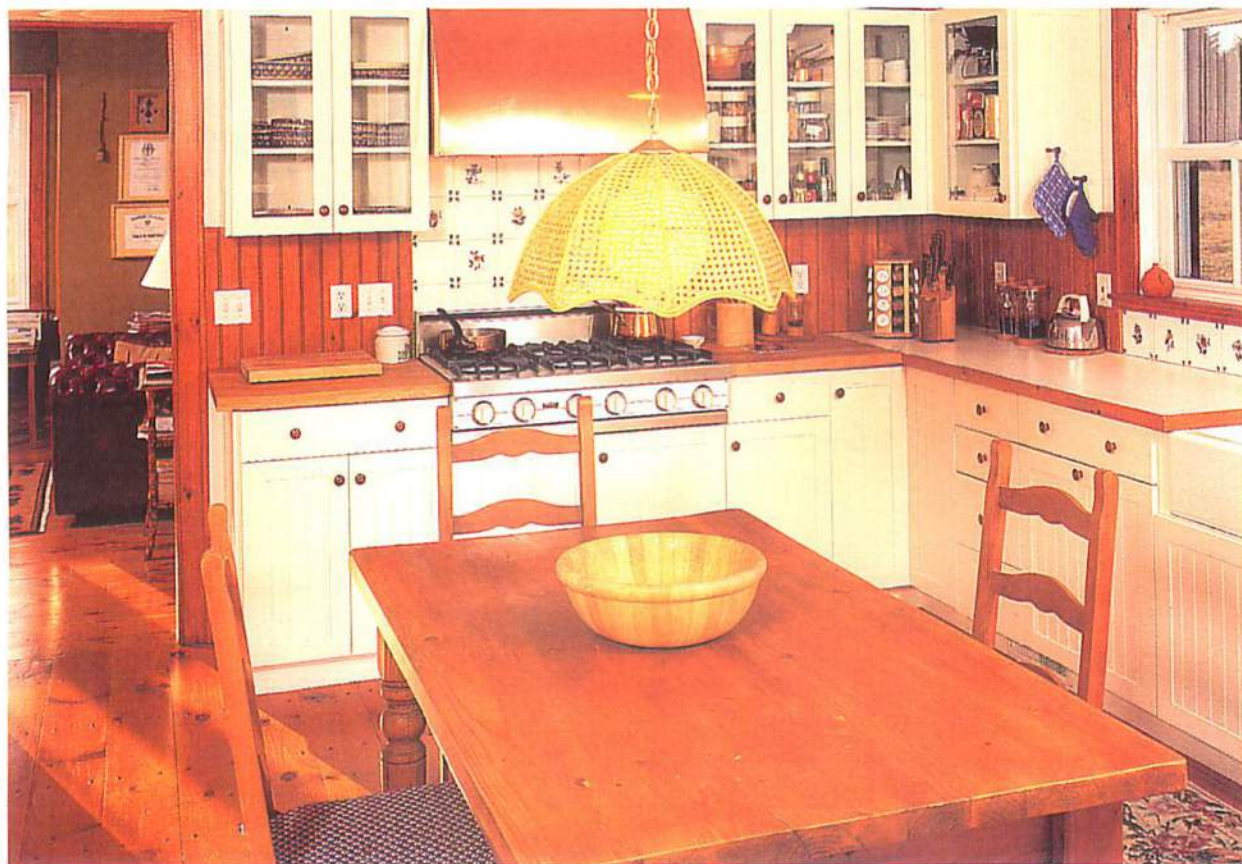
Low-moisture pine built-ins have a “colonial maple” finish, the same color the clients wanted for the floors. The kitchen (bottom, facing) includes a custom copper range hood, Viking cooktop and Sub-Zero refrigerator.

Telemark’s carpenters created all trim and built-ins on site using No. 2 pine, stained in a warm tone. The floors, also of pine, feature the same finish. Dalene face-nailed them with wrought head iron nails, after predrilling for every penetration. He used only pine with a moisture content of 8 to 10 percent for all of the home’s trim, to ensure greater stability.
